# Manhole Inspection Summary

Manhole # S15GG1023MH

**Location** Address: **2308 OSWEGO AVE**

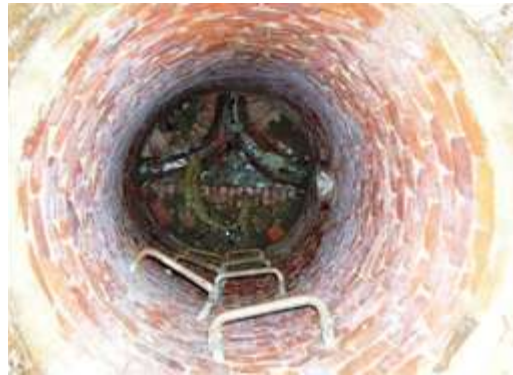
Top View

Corroded steps. Evidence of surcharge - Bench debris. Channel debris.

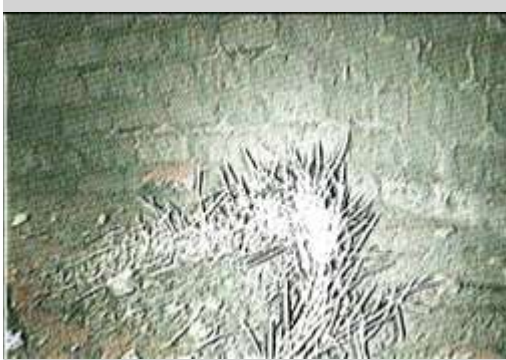
Defect

Barrel deterioration and infiltration. Bench debris - this is not root intrusion.

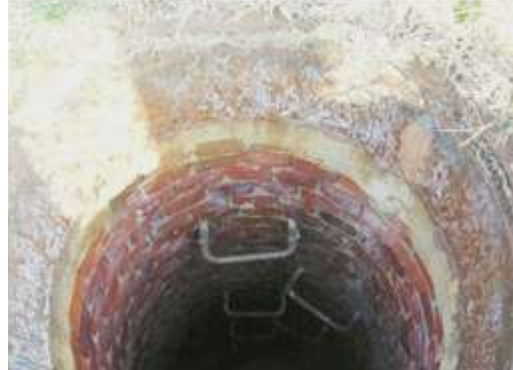
Defect

Adjustment deterioration and infiltration. Barrel infiltration.

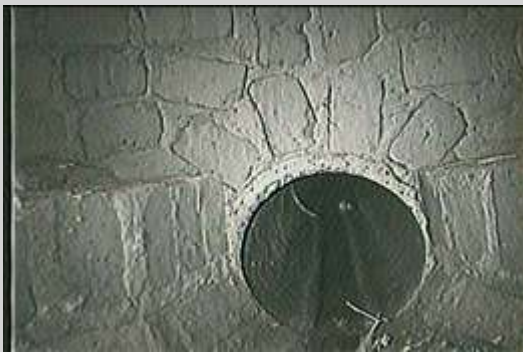
### 8 in. Circular Gravity Sewer Pipe Out @ 12 O'Clock

Deposits: ☐ None ☐ Mud ☐ Sludge ☐ Debris ☒ Grease

Infiltration: **None** Pipe Seal Cond: **Cracked**

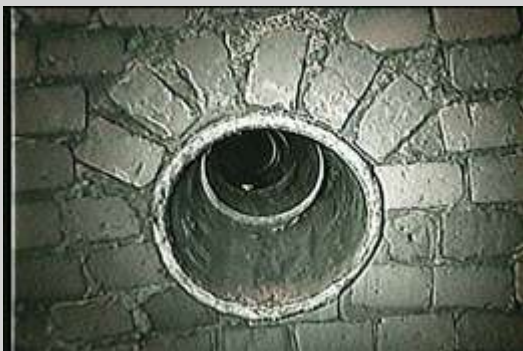
### 8 in. Circular Gravity Sewer Pipe In @ 3 O'Clock

Infiltration: **Evidence** Pipe Seal Cond: **Unknown**

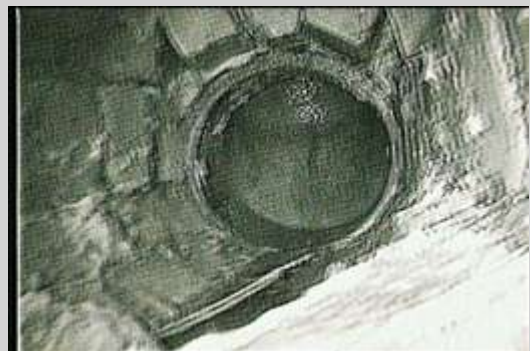
### Drop In @ 3 O'Clock

Barrel deterioration and infiltration. Channel deterioration.

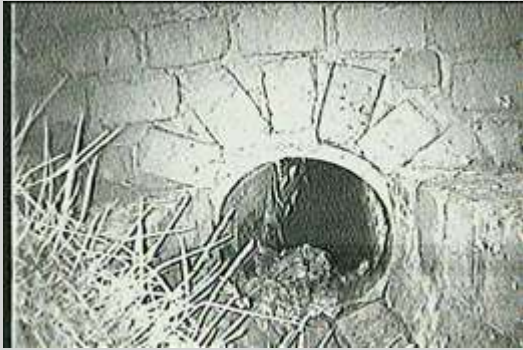
Pipe In @ 9 O'Clock

Deposits: ☐ None ☐ Mud ☐ Sludge ☒ **Debris** ☒ **Grease**

Infiltration: **Evidence**
